Investigation into Tritium Contamination at Vermont Yankee  
 Maps, images and diagrams

Vermont Department of Health Investigation into Contamination at Vermont Yankee Nuclear Power Station  
 February 4, 2011

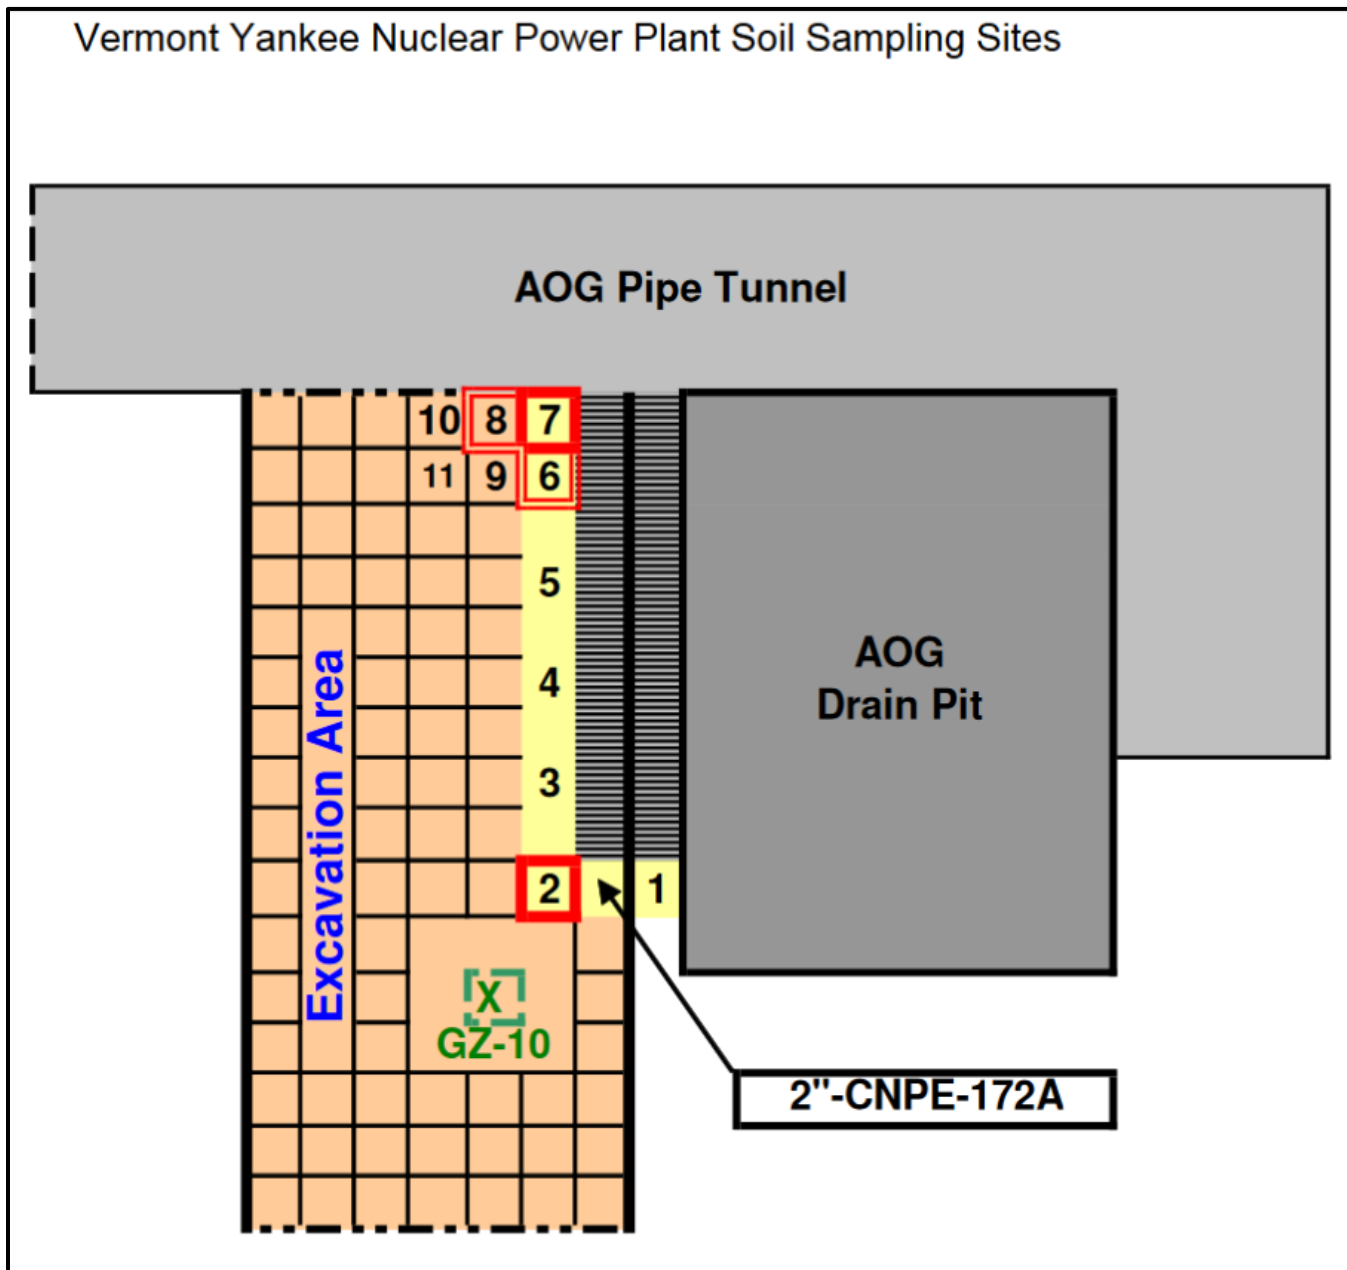
### AOG Pipe Tunnel Excavation Soil Sampling Sites

Diagram of the soil study area showing sites #1, #2 and #7, where soil samples taken have shown concentrations of Strontium-90

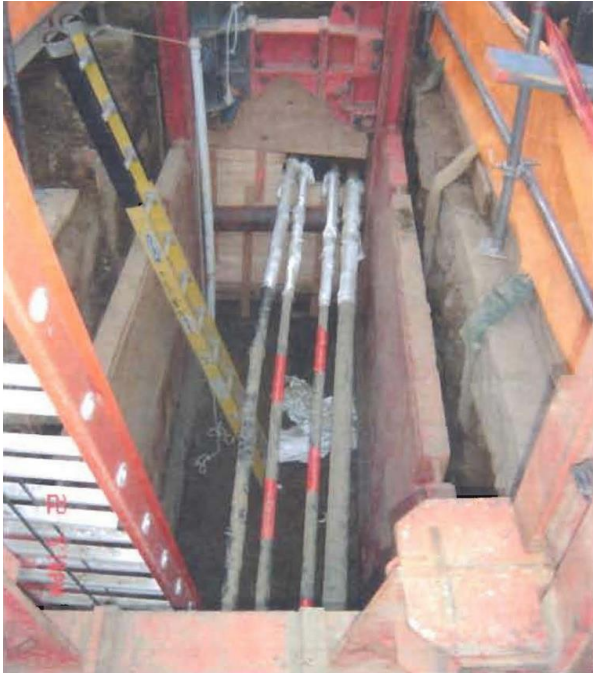
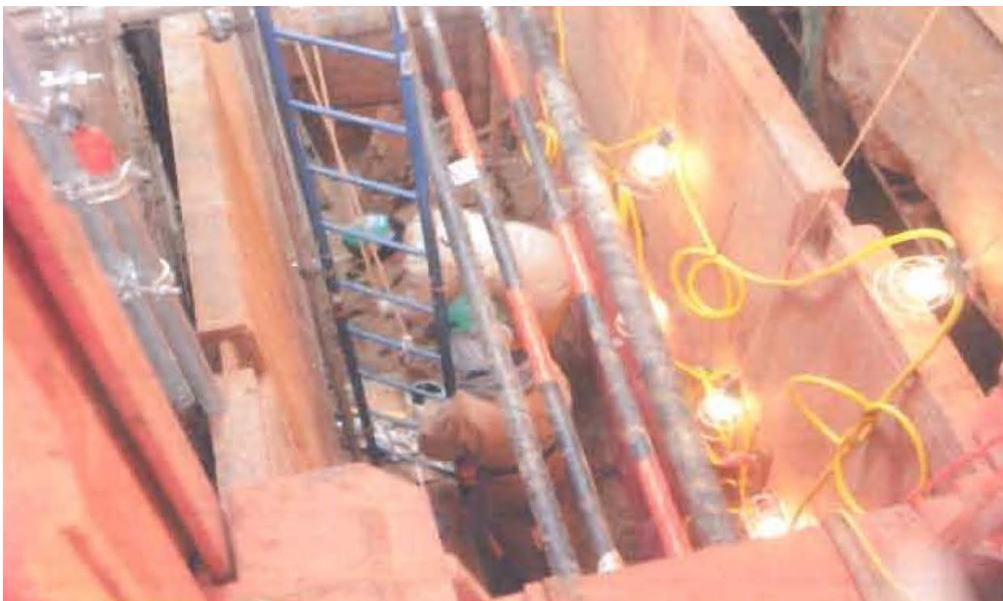
## AOG Pipe Tunnel Excavation

The excavation images are as viewed from the north end. The piping that runs through the center of the excavation includes two emergency diesel generator fuel lines. The lines required special precautions during the excavation, as did the electrical duct for the emergency diesel generators (the concrete structure on the right). Image 2 shows workers removing soils from the excavation. Samples of these soils have been analyzed for radioactivity. Samples near the AOG pipe tunnel included radioactive metals, indicating the leakage pathway from the tunnel into the environment.
